BOTM: August 2006

Hip Implant

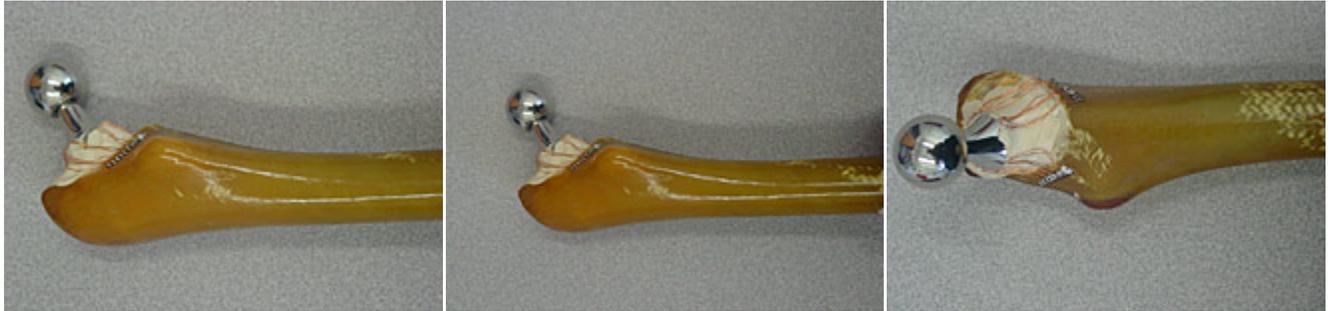
Legend: Hip Implant. Pictured here is a hip implant surrounded by model bone. In addition, strain gauges are seen which assist in experimentally measuring hip implant movement

within the bone cement and juxtaposed bone.
